The Department of Environment Protection and Energy Maanshan Iron & Steel Co. Ltd

2022 4 A#
2#3#4#

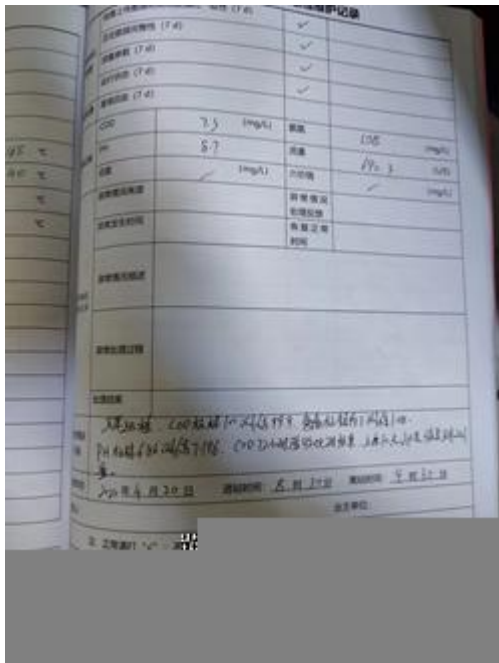
四、能控北 4#排涝泵站

2022 4 18 -4 20 4#
 (CODcr) 18 76.10 mg/L 19 142.57
 mg/L 20 71.06 mg/L COD
 72 COD

编辑常规监测因子标记记录

*标记类型： 调试

*监控点： 能控北4#排涝泵站

*子类型： 自动监测设备新装调试

*备注： 厂家调试

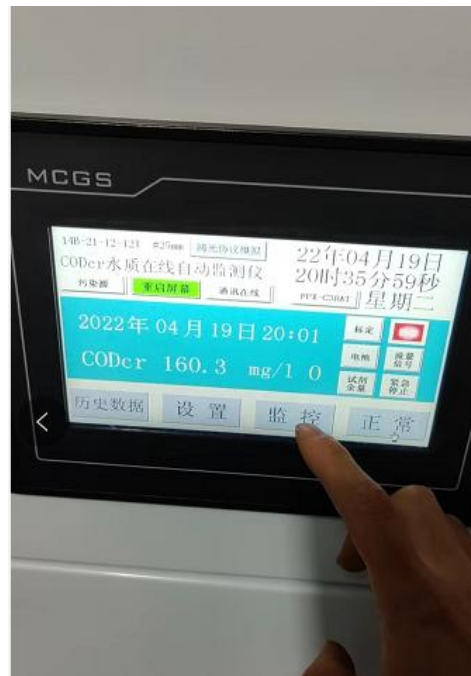
五、冷轧北水处理排口

2022 4 19 -4 20
 (CODcr) 19 70.982 mg/L 20 148.195
 mg/L COD 72
 COD
